St Martha Parish Council

Councillor Toynbee's Report for the meeting on 16th April 2026

Update re the lack of water entering the Gunpowder Mills at the 'snail' junction - April 2026

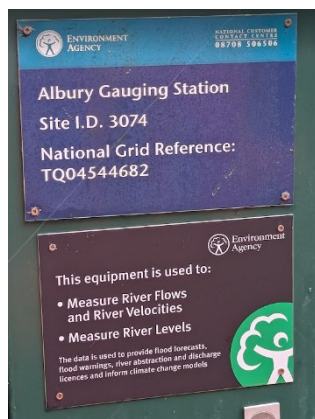
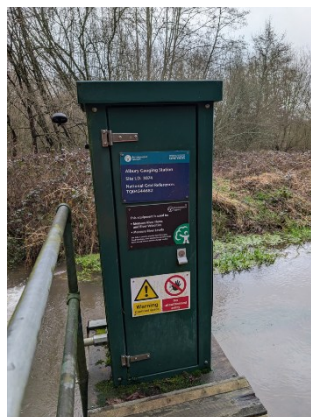
5. Opposite, on the south side of the road, the stream disappears into a gated property - 172 Dorking Road and cannot be traced further at this point.
6. I therefore accessed the stream from further south, via Blackheath Lane in Albury. Here the water is flowing strongly, and 'Albury Gauging Station' is at this point

It would therefore seem that whatever is stopping the water flowing is between the Albury Gauging Station and 172 Dorking Road, Chilworth.
