St Martha Parish Council

Councillor Toynbee's Report for the meeting on 16th April 2026

Update re the lack of water entering the Gunpowder Mills at the 'snail' junction - April 2026

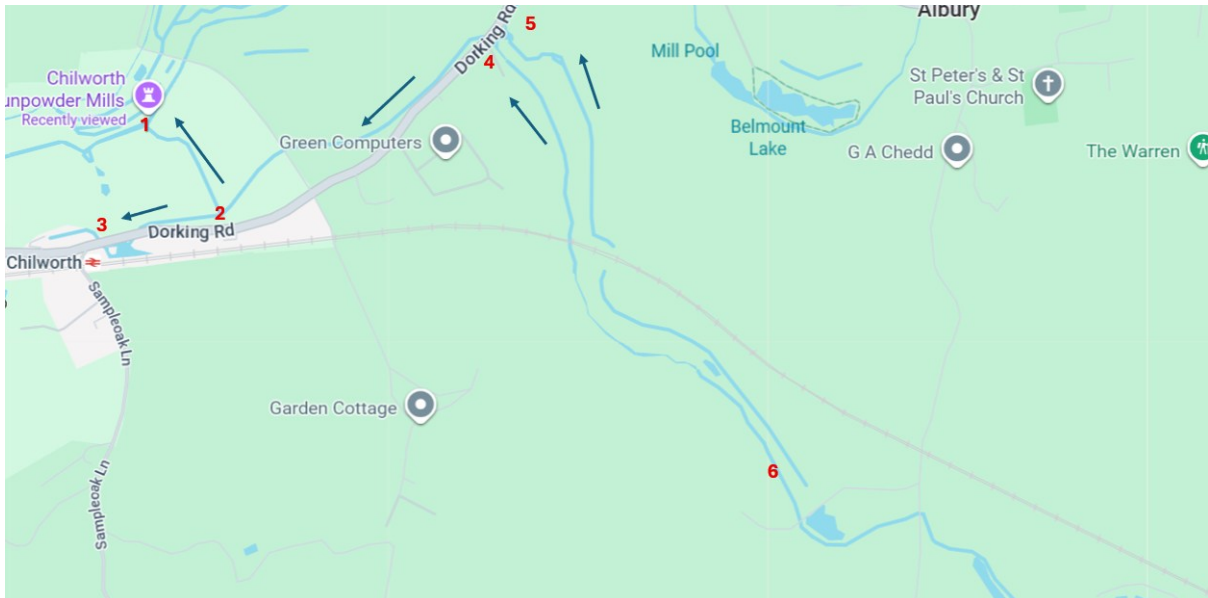
1. This is where the stream joins the cut at the Gunpowder Mills. The junction is known locally as 'The Snail' as there is a large wooden carved snail at this point.

2. The stream runs into the Gunpowder Mills, across a private field from point 2 on the map where it connects with another stream running west/east. There may be a sluice gate here, but at the moment we think that is not the cause of the blockage.
